**Screening of Candidate Corrosion Resistant Materials for
Coal Combustion Environments - Volume IV**

**Final Report
January 31, 1997**

**By
Daniel E. Boss**

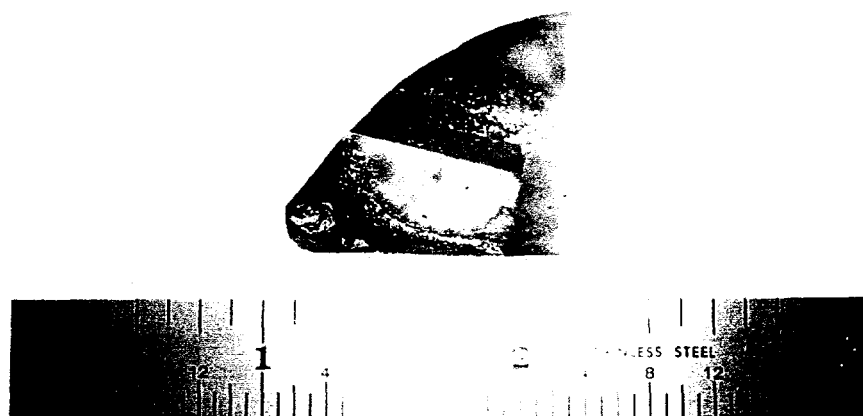
Figure 13. Al_2TiO_5 Sample #2 After Exposure

Aluminum titanate provides a good CTE match with SiC and it has been identified by other researchers^{8,16} as a promising candidate for coal combustion environments. Two samples were run of the Al_2TiO_5 because the first sample fell completely into the slag (Figure 12) during exposure. The second sample remained upright (Figure 13). The XRD pattern for Al_2TiO_5 did not show any compositional change after exposure, and only exhibited an increase in peak intensity and definition. The results of the examination of slag boundary for Sample #1 via SEM (Figure 14) and EDS (Table 6) did show some change in the Al_2TiO_5 . The EDS results for Area A show only Al and Ti present in the interior of the sample. In Area B, approximately 50 μm from the slag boundary, a significant level of Si and a trace amount of Fe all becoming enriched while the relative amount of Ti decreases. In the slag adjacent to the boundary, Al is enriched well above that found in the base slag (Area E). These results indicate some interaction between the Al_2TiO_5 and the slag, with the likely result of producing some substitution of Fe for Ti in the titanate structure, preferential removing of Al to enrich the slag, and possible the formation of Al-Si-O phases. The apparent extent of modification for the sample in the exposure time was on the order of 50 μm to 100 μm .
